# **3-YEAR ASBESTOS RE-INSPECTION REPORT**

## **GEORGE BANCROFT ELEMENTARY SCHOOL SCRANTON, PA**

PROJECT: #SSD.19\_751

July 2019

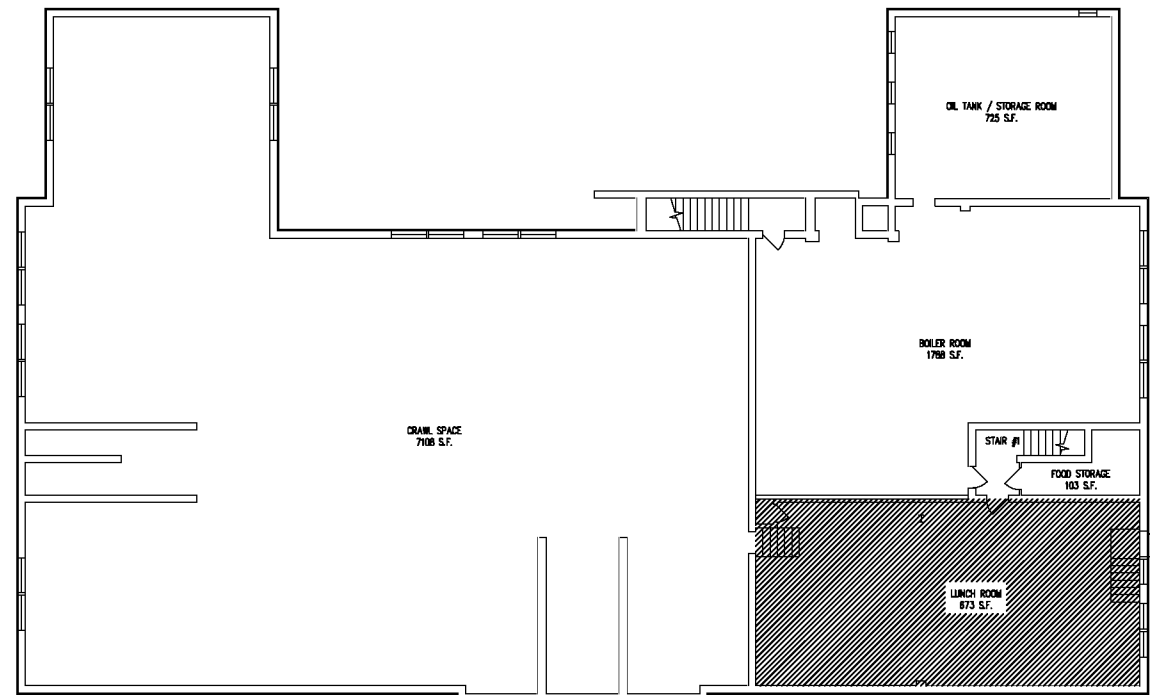
**BASEMENT PLAN**  
NOT TO SCALE

PLASTER (BASEMENT CAFETERIA AREA ONLY)

ASSUMED ASBESTOS CONTAINING  
SURFACING MATERIAL:  
- CHALKBOARD AND  
WALLBOARD MASTIC

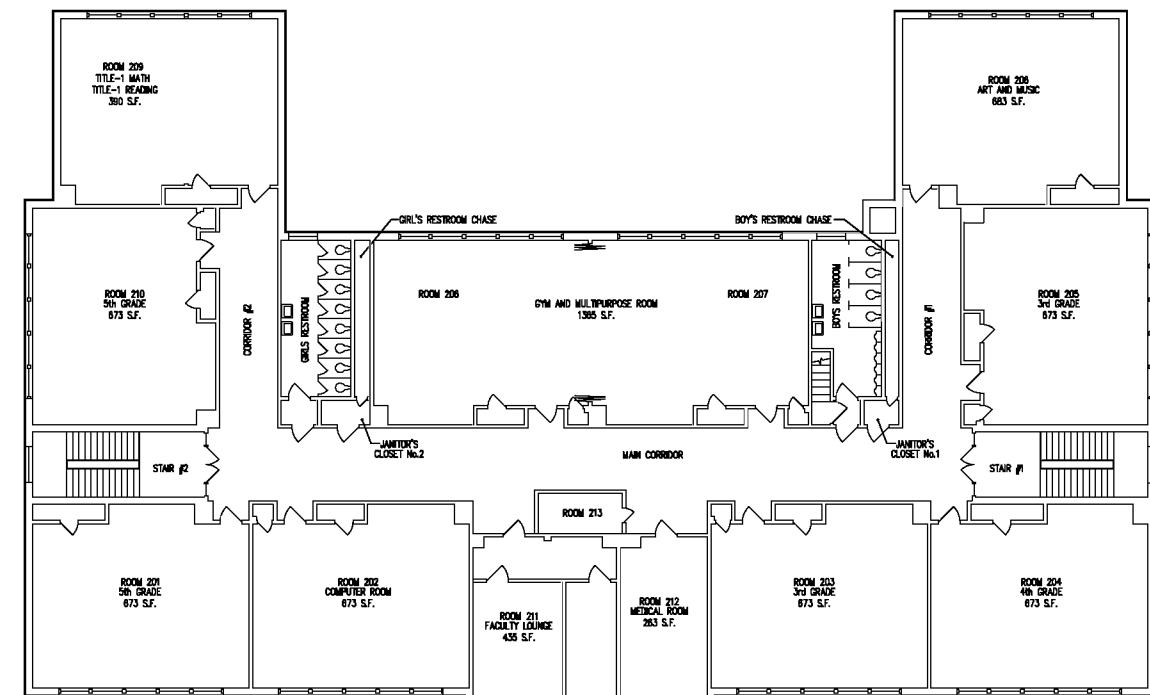
2ND FLOOR PLAN  
NOT TO SCALE

ASSUMED ASBESTOS CONTAINING  
SURFACING MATERIAL:  
- CHALKBOARD AND  
WALLBOARD MASTIC

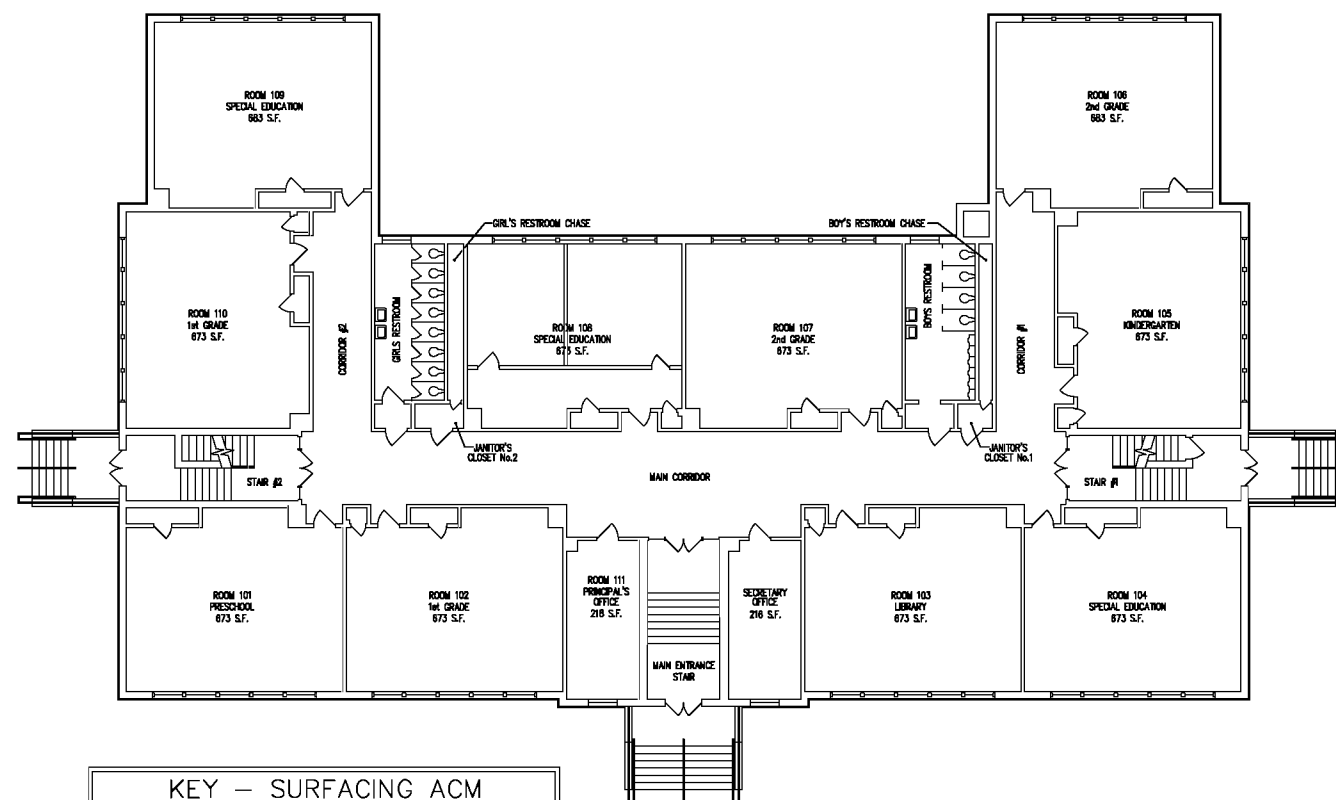
1ST FLOOR PLAN  
NOT TO SCALE

ASSUMED ASBESTOS CONTAINING  
SURFACING MATERIAL:  
- CHALKBOARD AND  
WALLBOARD MASTIC

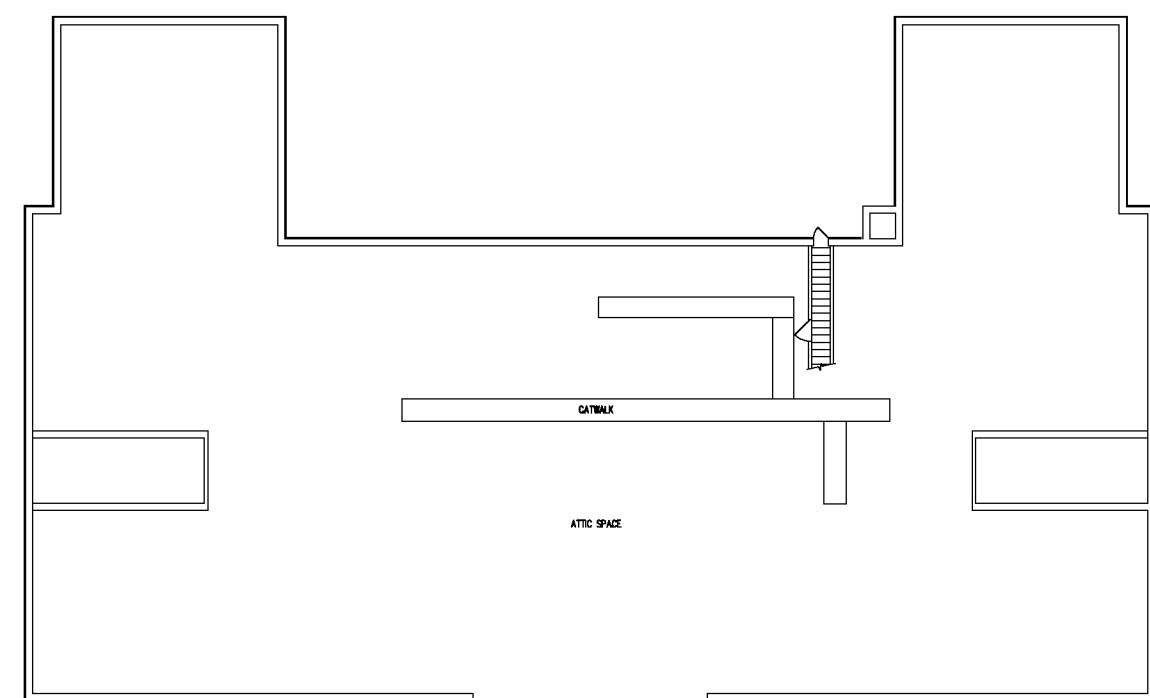
ATTIC PLAN  
NOT TO SCALE

ASSUMED ASBESTOS CONTAINING  
SURFACING MATERIALS WERE  
NOT FOUND ON THIS LEVEL

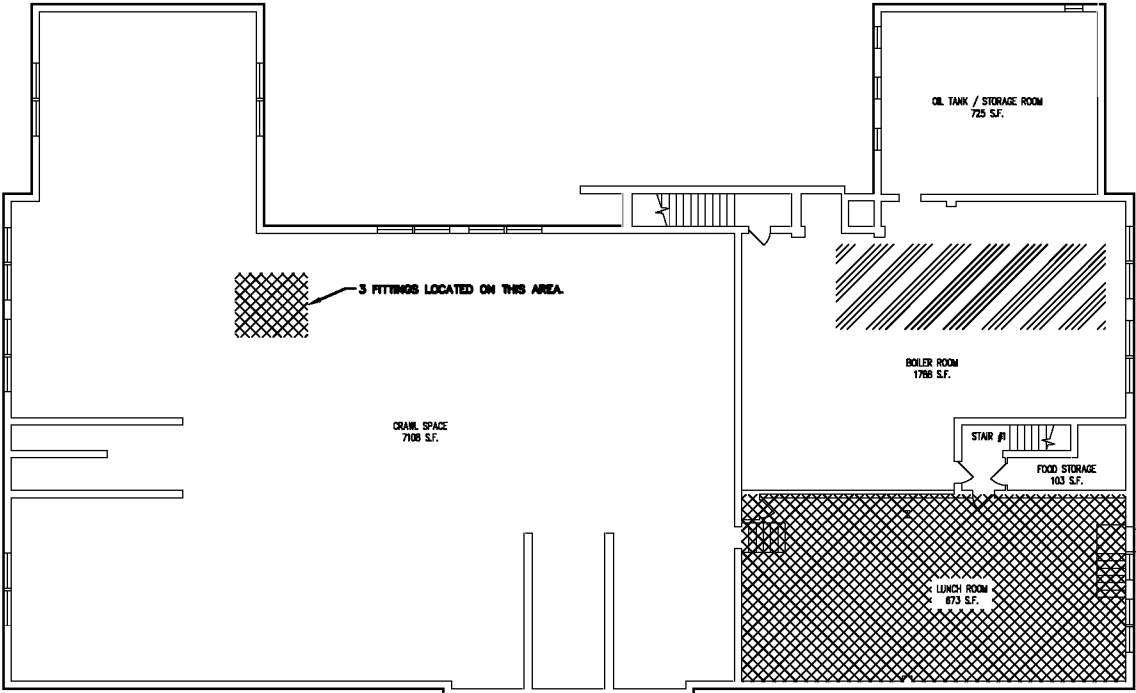
**BASEMENT PLAN**  
NOT TO SCALE

FITTINGS/PIPE INSULATION

BOILER BREECHING

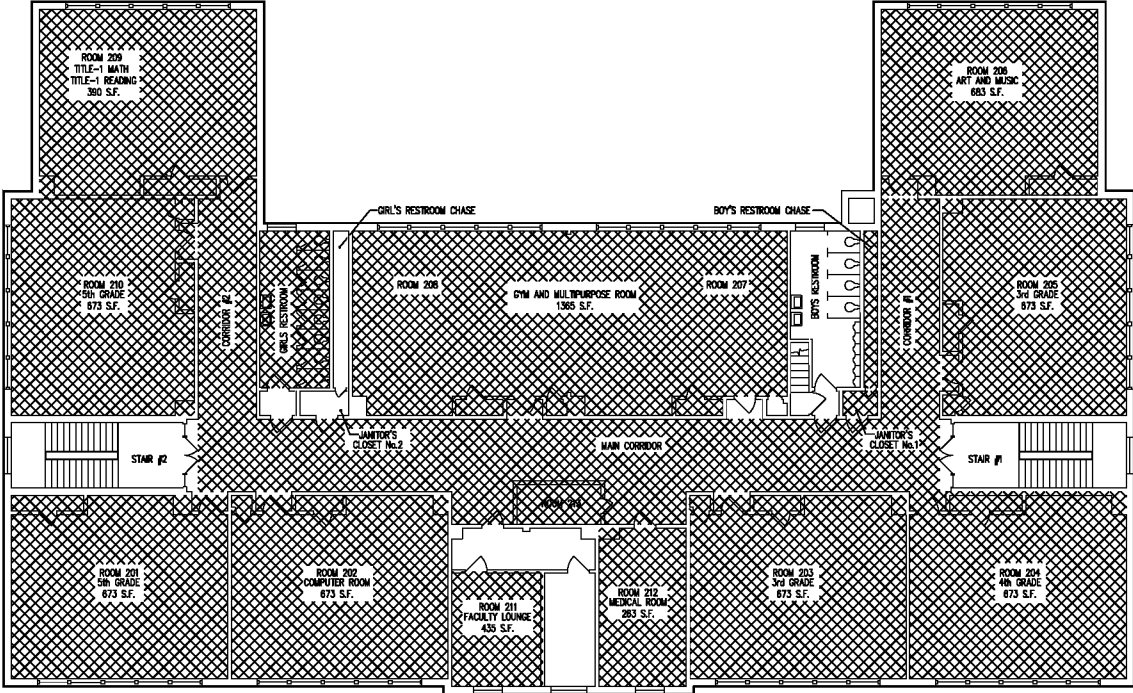
**2ND FLOOR PLAN**  
NOT TO SCALE

FITTINGS/PIPE INSULATION

NOTE: ON ALL FLOORS, ROOM VENTS FROM ATTIC TO ROOMS HAVE BLOW-IN INSULATION DEBRIS

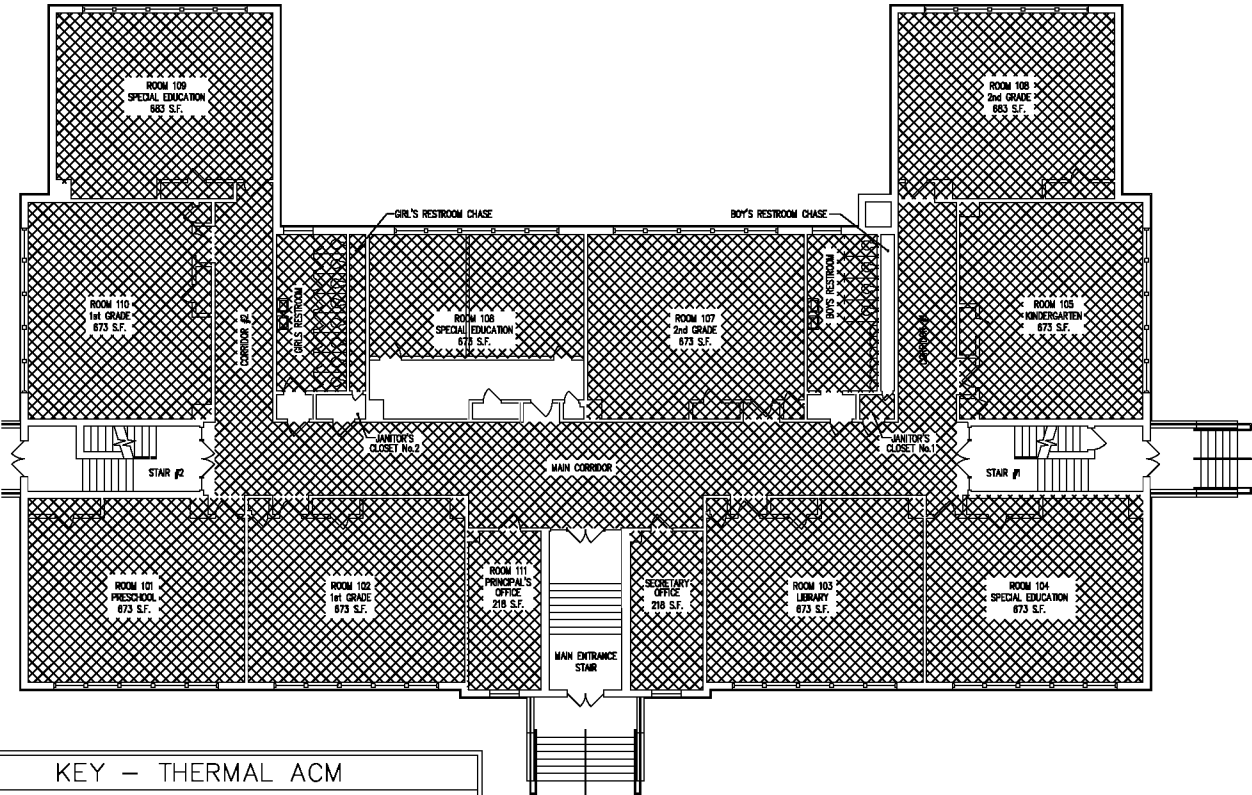
**1ST FLOOR PLAN**  
NOT TO SCALE

FITTINGS/PIPE INSULATION

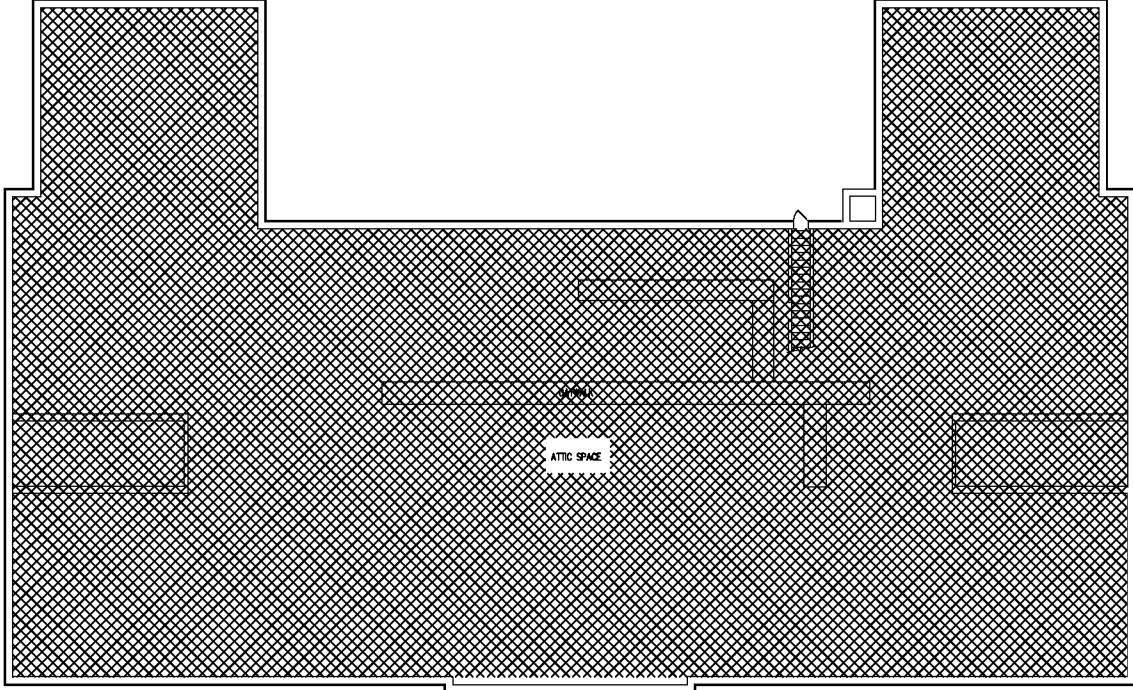
**ATTIC PLAN**  
NOT TO SCALE

Attic	Fittings and Pipe Insulation ( Approx. 20 - 30 Fittings )	TSI  SURFACE  Misc.	Assumed  or  <b>Analyzed</b>	<b>F</b>  NF-1  NF-2	G  D  SD	4	4	Repair / Remove - Debris from roof drain fittings on attic floor - Front corner above rooms 203 & 204 damaged insulation. (The above notes are from April 2017 6-month surveillance) - Blown in insulation was added in October 2017, unknown if debris and damaged items were repaired or removed

FITTINGS/PIPE INSULATION
